AXC F 2152 – CHANGE NOTES

Change notes for the AXC F 2152 controller

Application note
108427_en_07

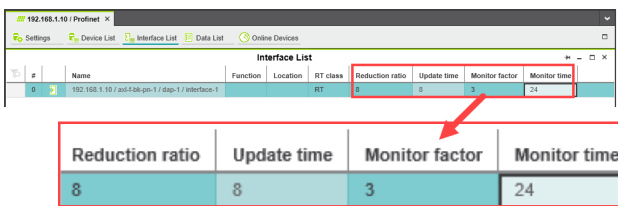
Figure 3 Monitor time

- Monitor time of PROFINET data
The PROFINET data monitor time must be at least 24 ms. The monitor time is the product of „Reduction ratio“ and „Monitor factor“ (in PLCnext Engineer: „Profinet“ editor group, „Interface list“ editor).
